**Construction Techniques  
for a  
Safer Bored Well**

**A Cooperative Project  
of  
Royall Pump and Well Company, Inc.  
and  
SAIF Water Wells, Inc.**

Bored and hand dug wells frequently test positive for coliform bacteria. The following improvements in bored well construction and maintenance were identified in an effort to improve the ability of the well to keep water sanitary.

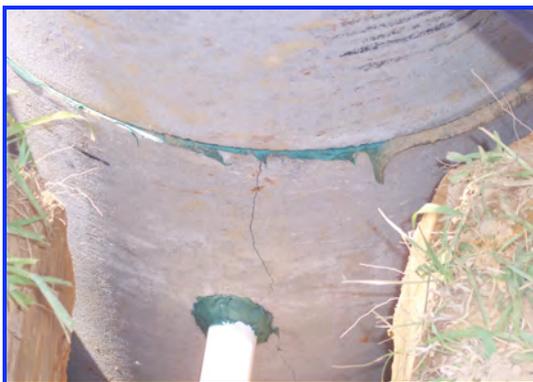
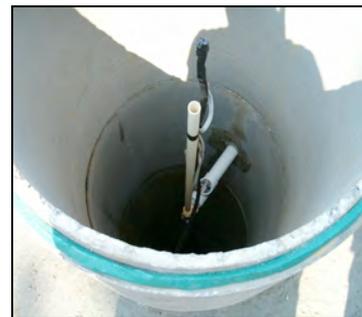
1.

The casings (also called curbs, tiles, or pipes), although hand-picked, had ragged edges, which were knocked off with a hammer.

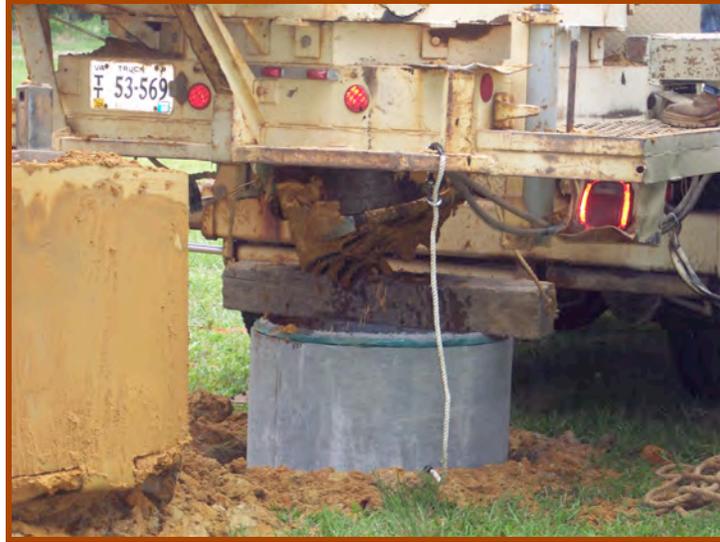
2.

Each curb was fitted by hand with a concrete sealant, which effectively sealed the joints from the top to two feet below the water table. (CS-665 from ConSeal was used.)

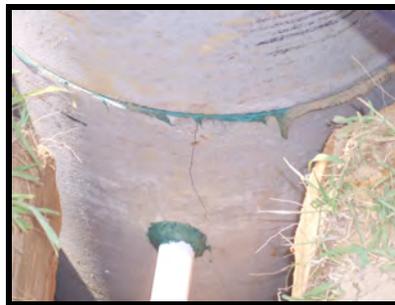
3.

After the curbs were in place they were pressed with the weight of the well rig to help dislodge sediment between the curbs and tighten up the fit.

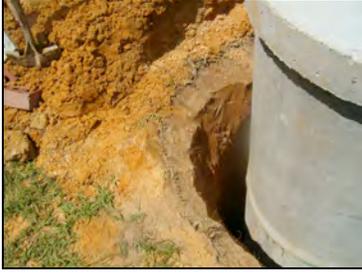
4.

A ten-foot sleeve was placed through the well curb, slanted down into the trench for the plumbing, and triple sealed to the plumbing line so there is no possibility of sediment feeding back into the well through the sleeve in between the waterline and electrical lines that go through the sleeve.

The sleeve was put in place before grouting so that the grout would form a seal around it at the curb/casing.

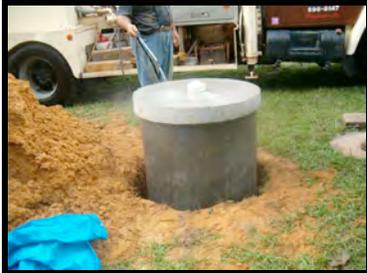
5.

The top edge of the annular space was beveled so that, when the grout was poured, the apron would be an extension of the grout itself and not likely to crack with freezing.

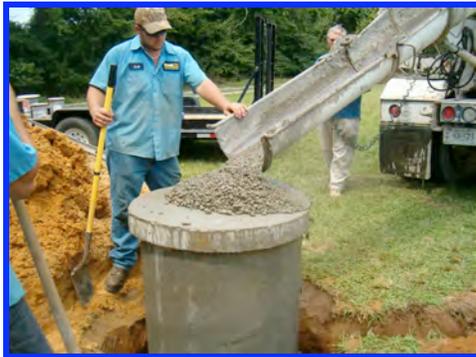
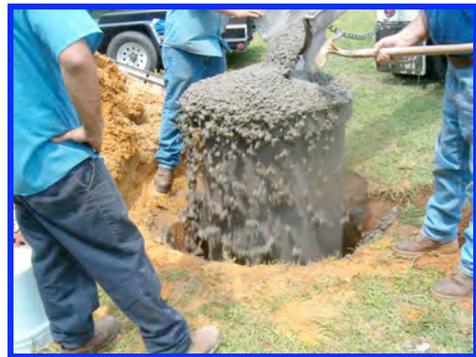
6.

Any mud on the sides of the well was gently washed off with water from a pump so that it would not interfere with a smooth grout.

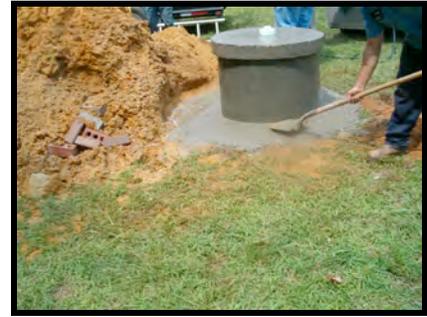
8.

The grout was smoothed by hand and the homeowner summoned to record anything they wished while the cement was wet.

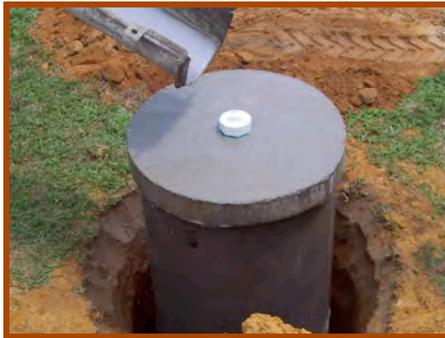
9.

The cap contained a port hole in the center. This one was 4 inches, but we would prefer bigger in the future. (A hole was cut in the cap and the port hole glued in.)

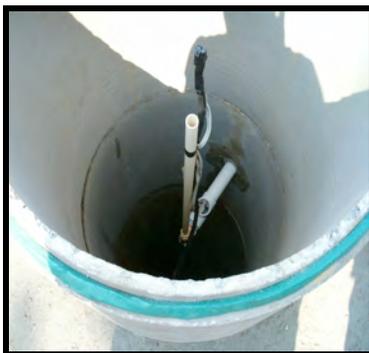
10.

The pump was installed on a pitless adapter and a pipe/handle inserted in the top socket. If the pump needs to be serviced in the future, the service person can simply unscrew the lid on the port hole and pull the pump straight up--without going in the well or taking the cap off!

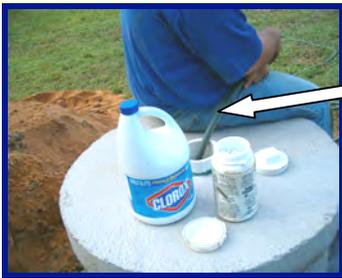
11.

Because there is a porthole and pitless adapter the cap could be sealed with a concrete sealant.

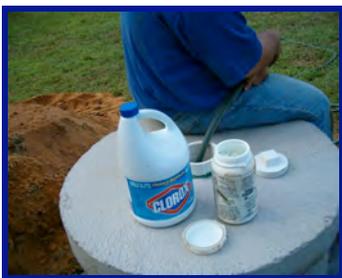
12.

The well was chlorinated, using the amount required by state regulations. The chlorine was circulated in the well water for 30 minutes by attaching a hose to an outside faucet and running it back into the well. (Just dumping the chlorine in the well is not adequate.)
